LEVEL 3

# Your survey report

12 Any Street, Any Town, AB1 2CD

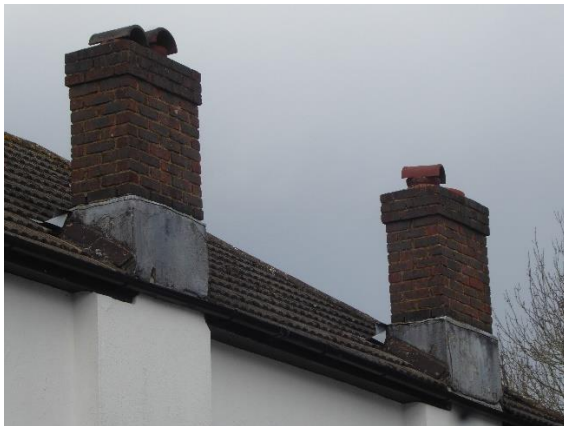
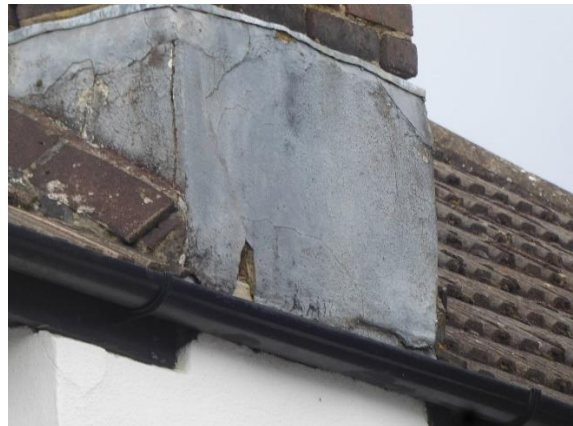
There are two chimney stacks to the right side of the building serving the front and rear reception rooms/bedrooms above. They are constructed of solid brickwork, finished in facing brick to the top, where the brickwork and pointing are in reasonable condition, but some minor missing pointing was noted in places particularly to the rear stack. They appear to retain the original uncapped clay pots but pot caps have been installed to both at the front and one of the rear pots.

There is an unusual arrangement to the base of both chimney stacks where there appears to be a sheet metal damp proof course, which is considered to be good quality construction, with painted render beneath. However, the render is in poor condition, with general cracking, and a missing area to the front stack. There does appear to be some sheet metal flashings to the top side of the chimney stack but there is tile flashings to the sides that are not the most durable and damp staining was found to the walls, close to the ceiling line in both of the bedrooms. Damp readings were found when using a moisture meter to the staining in the rear bedroom but none to the staining in the front bedroom. However, there is likely to be some damp penetration where both stacks should be overhauled to improve water tightness and address the aforementioned defects.

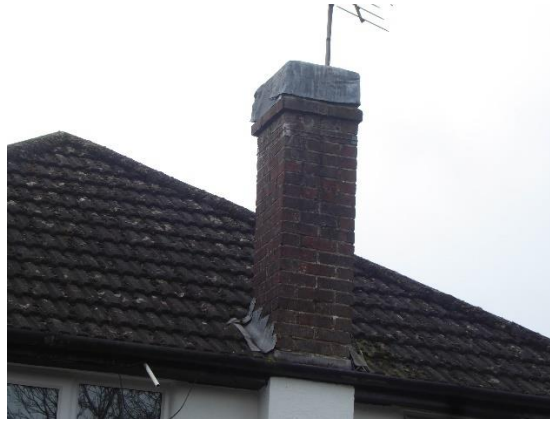
There is a further chimney stack to the rear of the building that would have originally served a floor mounted boiler or stove in the kitchen. This is fully finished in facing brick, where the brickwork and pointing are worn, but in reasonable condition. It has had the pots removed with a full lead cover applied and there are sheet and stepped metal flashings to create the seals between it and tile covering, where there is algae growth to the left side. The flashings appear to be performing effectively, as no damp penetration was found internally, but I would recommend it is closely inspected as part of an overhaul of the other stacks. I would ideally recommend that it is removed in its entirety, as it serves no purpose and will always be a weak point for damp penetration. You may wish to consider doing the same to the side chimney stacks, as the majority of the internal fireplaces have been blocked up, but there is an open and functional flue to the rear reception

room and the others could be reinstated if required.

As damp penetration was found in the living space, a condition rating of three has been provided.

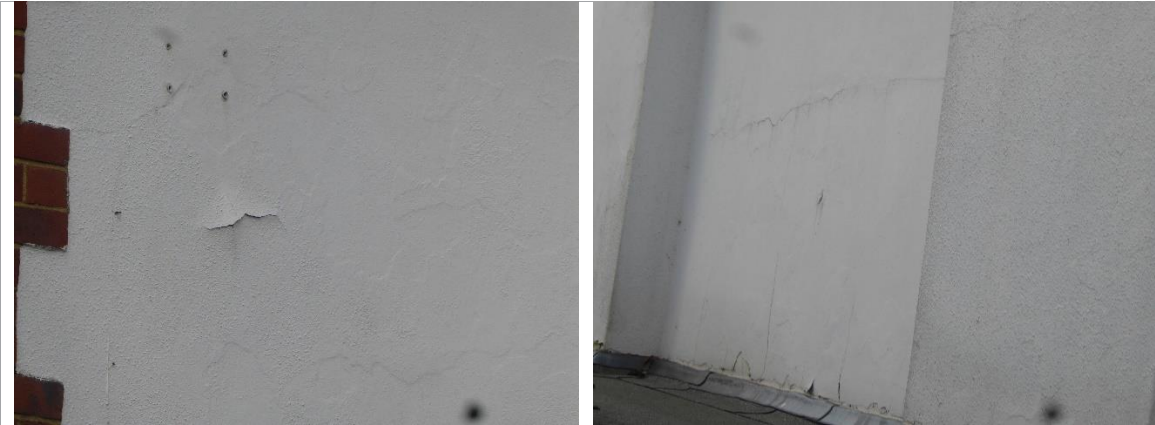
The outside walls are of cavity brick construction, possibly with an inner blockwork skin, but this could not be verified due to internal plaster finishes. The front elevation is finished in facing brick and the brickwork and pointing are in reasonable condition. There is a projection to the front right of the building and no differential movement was noted between this and the main structure. There is some corbelled tile work beneath the eaves at the left side, which is part of the architectural design, that also appear to be in reasonable condition.

The remainder of the elevations are finished with painted render that is likely to be original and while the render appears to be adequately bonded to the brickwork behind, there will almost certainly be some areas that are blown, where it has become detached in a property of this age. Cosmetic issues were noted where it has been painted many times over the years and the paint is beginning to crack/peel. It is hollow to the touch in other areas, where it has become detached and this is a particularly difficult issue to rectify, where you may wish to take specialist advice, but it is simply a cosmetic problem that has no structural implications.

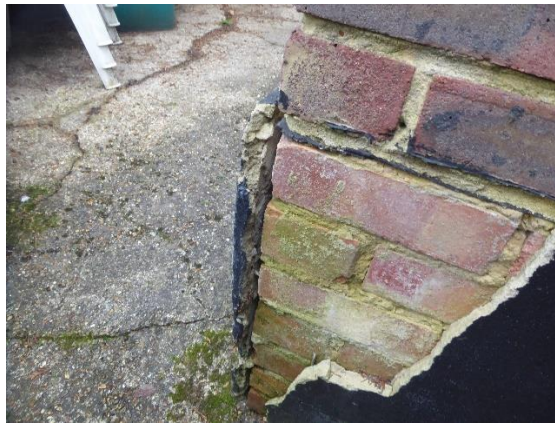
There is a small single storey projection to the rear left that is believed to be part of the original structure, where the building further steps at first floor level, and no differential movement was noted. Openings have been created in these areas to incorporate the single storey extension, where the support of RSJ's (rolled steel joists) or similar supporting beams would have been necessary. There is some boxing to the ceiling, as well as a substantial opening to the extended part, that would indicate this has been provided but they could not be inspected. However, there is no cracking or distortion around the openings that would indicate inadequate support or the potential for failure.

The damp proof course to the main house could not be seen as it is covered by a cement plinth that is painted in black. It is fairly old and worn, with some general cracking, and blown areas that have become detached where repairs and maintenance would be beneficial, but is not thought to be urgent. This has the potential to bridge the damp proof course, which in a building of this age is likely to be bitumen felt, but it appears to be performing effectively in general as no unusually high damp readings were found around the base of the external walls, internally, where accessible to test with a moisture meter, which is less likely to occur with cavity construction.

I could see no evidence that cavity wall insulation has been installed, as there would be filled drill holes where it has been blown in between the cavities at a later date, and while this would improve the thermal efficiency of the building, it can also cause issues with bridging of the damp proof course and cold bridging if it is not properly distributed throughout the cavities. I would not recommend its installation unless it is undertaken by a reputable contractor that provide lengthy guarantees.

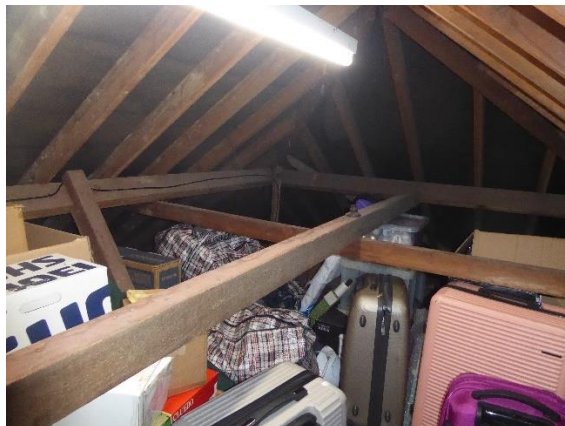
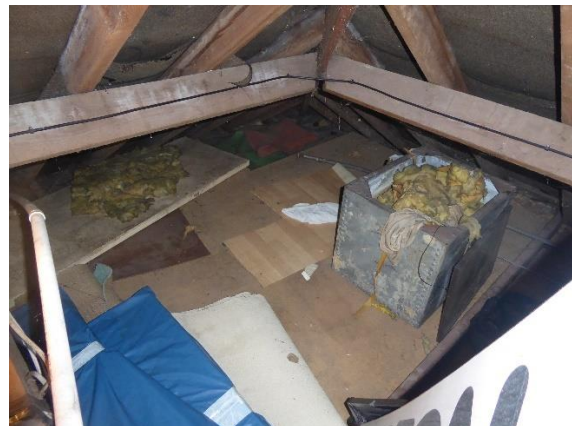
The roof is constructed of the original traditional timber frame, which consists of rafters supported by purlins, struts and collars. I would expect there to have been some additional bracing provided for the increased weight of the interlocking concrete tile covering, but the frame does appear to be carrying the weight of the tiles satisfactorily, having bedded down only somewhat unevenly, with no timber defects such as rot or worm found to be affecting visible structural timbers.

The roof pitches are lined with bitumen felt, which would have been installed as part of the replacement covering, and it provides secondary weather protection, but does not allow for any ventilation. There are no vent tiles or vents to the soffits and the ventilation to the roof structure should ideally be improved, as some minor mould growth was noted to the rafters, with the installation of vent tiles/soffit vents, but the mould is minor and this is not thought to be urgent.

There is boarding to the ceiling joists to provide walking and storage space with large amounts of stored possessions, which limited inspection, but where it could be seen around the eave areas there is a minimal amount of fibreglass wool insulation material and it is missing beneath the cold water storage tank. This requires significant improvement as the current recommended minimum thickness for a mineral wool type is for 270mm.

No major defects were noted to the roof structure, but the insulation and ventilation requires improvement.

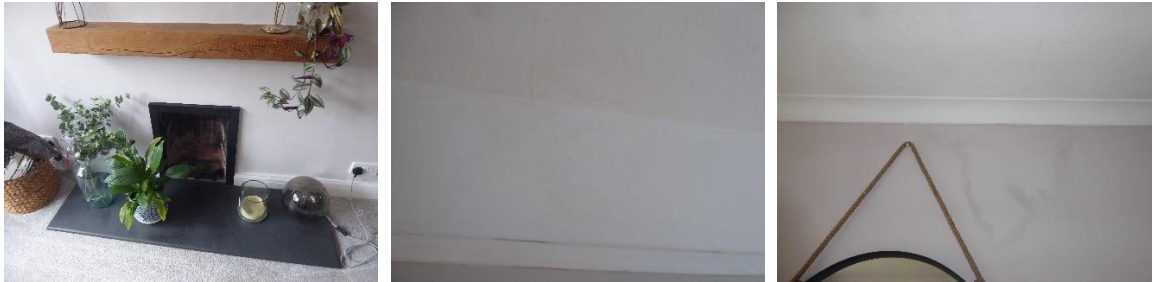
The chimney breasts are external, which are rendered and painted, and appear to be in reasonable condition, beyond some peeling paintwork. The rear one tapers into the wall at low level where it would have served a floor mounted boiler or stove in the kitchen and has the flue for the current boiler penetrating through it.

As mentioned above, damp penetration was found causing water staining and damage to the walls/ceilings of the side stacks, where an overhaul to improve water tightness will be required and these stacks, if you do not intend to use them, could be removed in their entirety as they will always be a weak point for damp penetration.

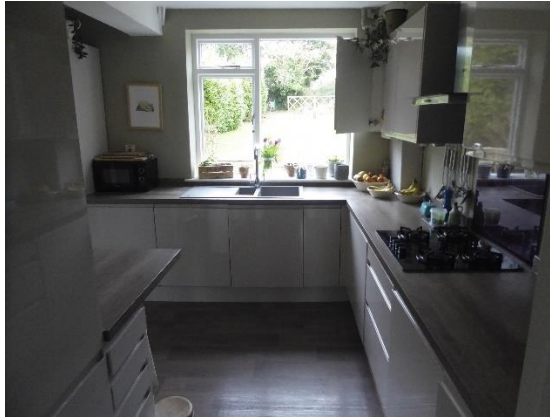
The kitchen has a modern range of base and wall units that are well presented. There are composite worktops, a 1.5 bowl composite sink, gas hob, electric oven and integrated appliances. No significant defects were noted but there is some general water damage to the composite worktops where the edges have expanded and some of the covering is loose. None of the

equipment was tested and while some improvements could be made, it is reasonably well presented and appears to function effectively.

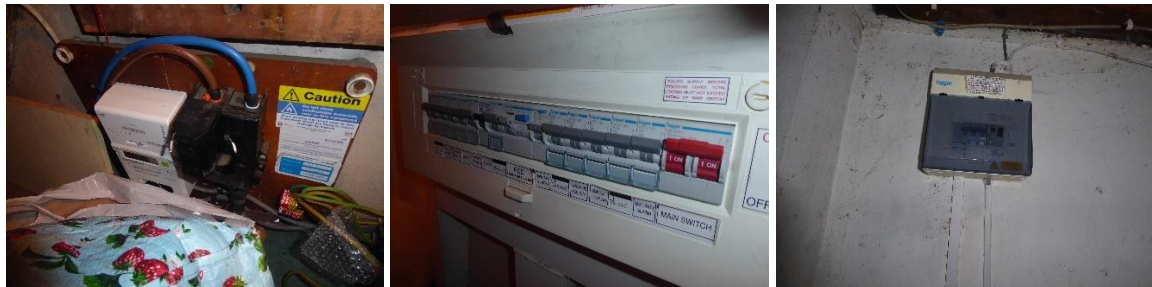
Mains electricity is supplied and the meter is located in the understair cupboard, which appears to be a modern digital smart meter replacement. The consumer unit is in the same location, which is a relatively modern replacement that was likely installed in 2007, as there is a date on the front, and this has miniature circuit breaker fusing. The sockets and switches are relatively modern, which could indicate some rewiring, but this could not be confirmed and as I am unable to test this type of installation, I recommend that you have it tested by a qualified electrician to establish its efficiency before proceeding.

There is a separate consumer unit in the garage, which should comply with regulations, but the lighting was not working and inspection was limited. This should be tested at the same time as the main system.

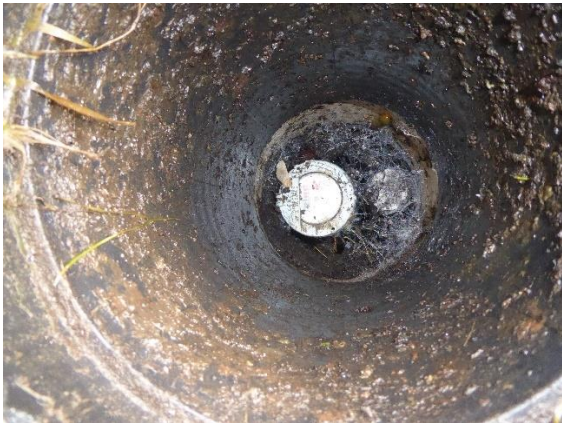
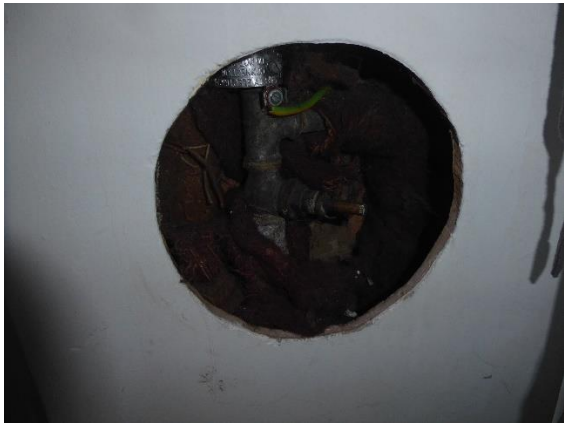
Mains water is supplied and there is an external water stop valve cover located on the raised grass area to the in-an-out driveway close to the street. This is a modern type that has a meter beneath and likely a quarter turn stop valve that could not be inspected as there is some detritus.

The mains internal water stop valve appears to be behind boxed services to the cupboard off the kitchen where it was noted that the tap head is missing and it is likely that the property retains the original lead mains water feed pipe from the street into the house. This should ideally be upgraded to PVC, but if the original lead does remain, this is not thought to be a significant hazard as calcification on the inside of the pipe forms a protective layer. There also appears to be some lead providing a feed to the ground floor WC, where there is potentially another stop valve.

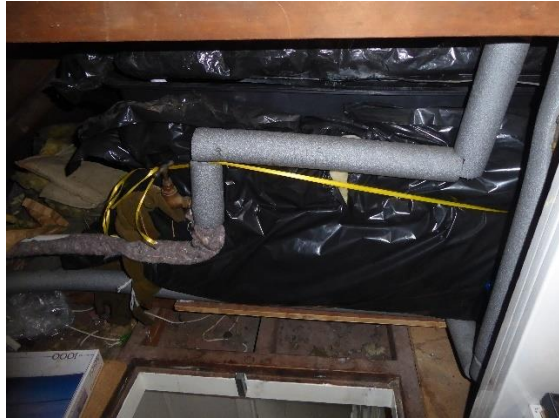
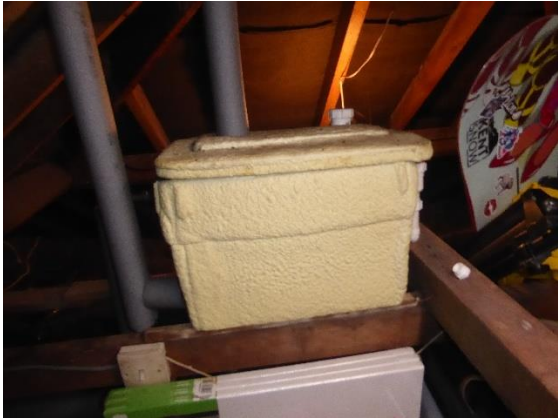
The majority of the pipework is concealed and could not be inspected but where it could be seen it is in copper and there is likely to be some modern plastic where fittings have been upgraded. The supply terminates in the roof space where there is a plastic cold water storage tank that has some basic quality lagging that could be improved. There is also a smaller plastic header tank for the central heating system that has had a spray foam insulation type applied which should be sufficient. This is a fairly dated arrangement where there is the potential for contamination to tanks, and I would recommend that it is upgraded to a modern type that is at mains pressure with a separate pressure vessel provided to remove the requirement for a header tank for the central heating system. You should take specialist advice in this respect but no significant defects were

noted, beyond some dated pipework and a missing tap head to what is believed to be the mains internal water stop valve.

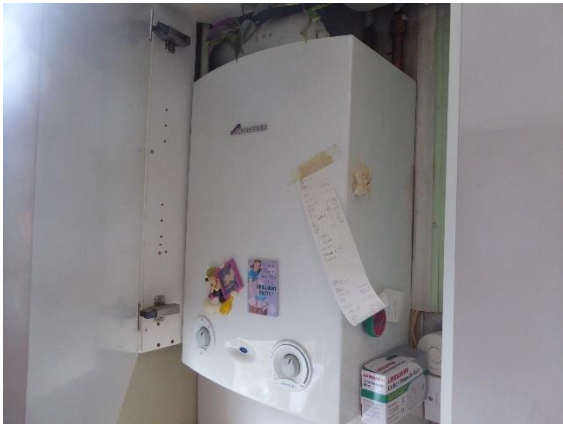
The house is centrally heated by pressed steel radiators, most of which are relatively modern replacements that have convector fins and individual thermostatic control valves, but there are some older types and unusually, some of the retro-fitting was undertaken using surface mounted pipework rather than utilising subfloor voids, which is unattractive. The hot water is provided by a relatively modern Worcester Bosch indirect boiler, that is wall mounted in the kitchen with a flue exiting out of the rear wall. The system was not in use during inspection, and as I am unable to test this type of installation, I recommend that you have it tested by a qualified heating engineer to establish its efficiency before proceeding.

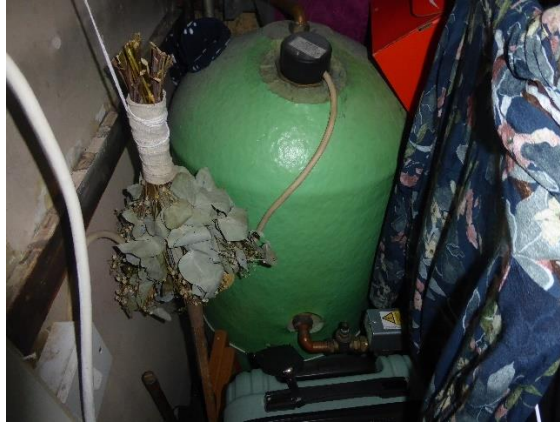
The same boiler provides the hot water for the tap outlets and it is stored in the copper hot water storage cylinder in the first floor landing airing cupboard. This is a reasonably modern tank with built-in insulation but it is a somewhat dated arrangement that could be improved. However, while the system was not tested, hot water was available during inspection and no leaks were found to visible pipes. You should have this system tested by the qualified heating engineer at the same

time as the central heating system.
