LEVEL 2

Your survey report

Flat 4, This Block, New Street, Old Town, GH12 3JK

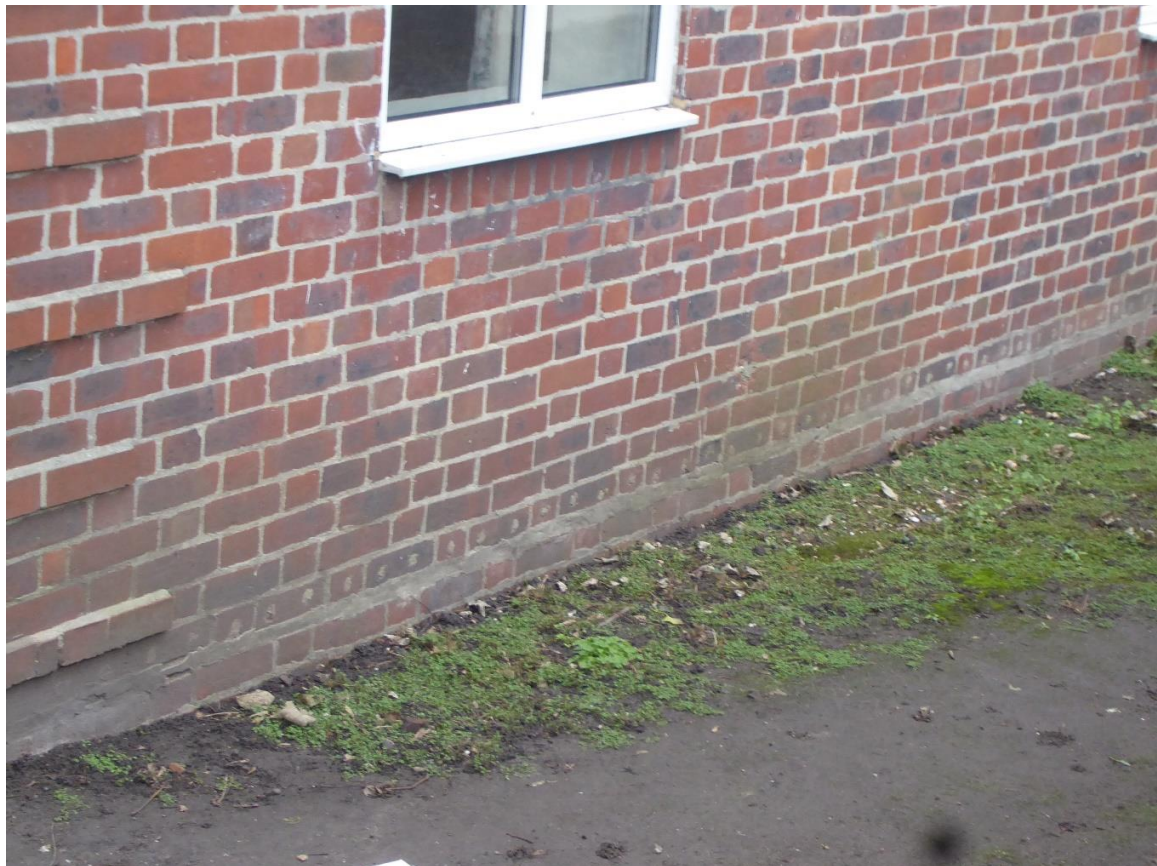
The outside walls are constructed of solid brickwork that are unusually thick at a brick and a half wide, which is typical with 1930's mansion blocks, and they are in reasonable condition likely having had some replacement cement mortar pointing to the brickwork joints. There are various steps and projections around the building where no differential movement was noted and the window lintels are soldier courses of brickwork, likely with some concealed timber or concrete,

where no cracking or distortion was noted around openings that would indicate potential failure. Subsoils in this area are chalk, which is a reliable building foundation and structural movement is unusual. While the building has suffered from some slight uneven bedding down, this is to be expected and is a minor defect that is not thought to have any serious structural significance.

The damp proof course could not be seen but in a building of this age it is likely to be a double layer of slate or possibly bitumen felt. It appears to be performing effectively in general, as no unusually high damp readings were found around the base of the external walls, internally, where accessible to test with a moisture meter. However, it was noted that there are a series of filled drill holes to the left side of the subject property where an injected resin damp proof course has been installed. There has obviously been a historic issue, that could be related to the potential surface water flooding, but this work appears to have been successful as no damp readings were found internally. This type of work usually comes with lengthy guarantees/warranties and I recommend you make further enquiries with the vendor in this respect.

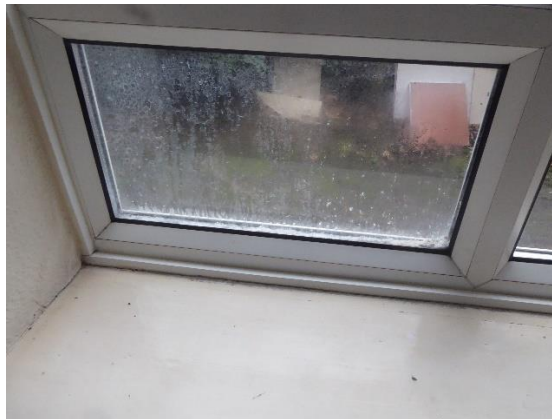
The windows are uPVC double glazed replacements that are Everest and were likely installed or manufactured around 1999, as some dates could be seen in places. They are in reasonable condition and appear to function effectively, but some minor adjustments to latches and hinges could be required in places and a blown glazing pane was noted to a small lower section of the living room. This is not thought to be a significant issue as the glass can be replaced in isolation but some general repairs and maintenance can be expected.

There is black mould growth around the window reveals internally, but these do not show any damp readings and is therefore likely due to poor air management where cosmetic improvements will be required.

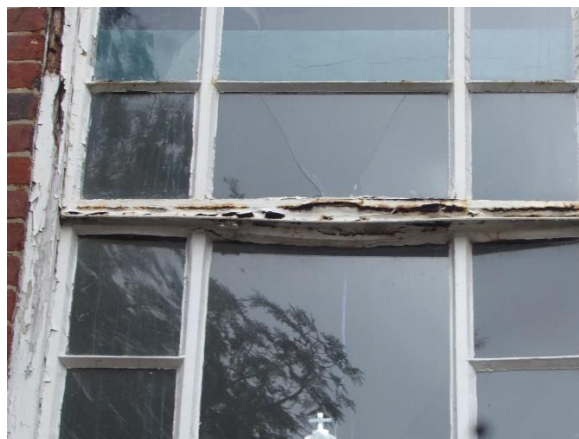
The windows to the communal areas appear to be original timber framed, single glazed, types that are in particularly poor condition with significant rot and broken glass noted to the stairwell window above the main entrance that will require replacement. You should ensure that an adequate sinking fund has been built up to address these issues and it does not affect your level of service charge contribution.

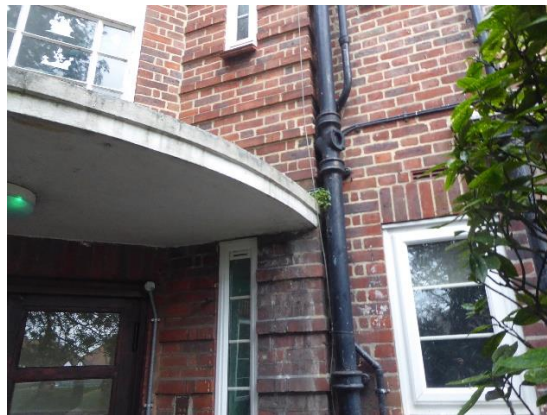
There is no conservatory or porch but there are canopy roofs above the main entrances that appear to be cast concrete, likely with an asphalt type covering, and defects were noted as there is plant growth at the right side where improvement should be made.

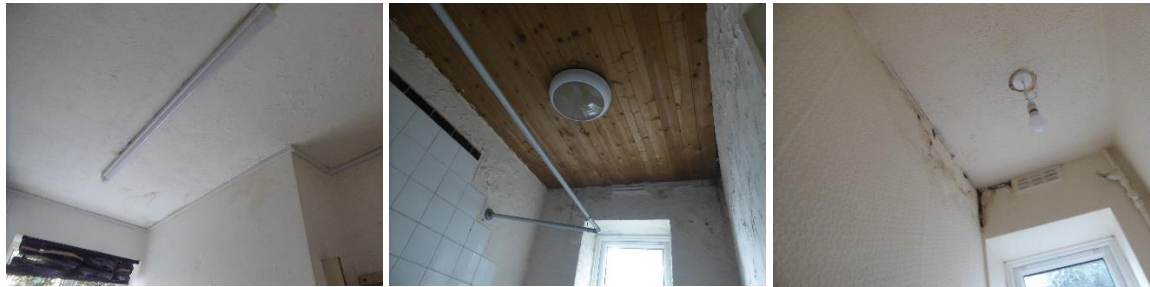
The ceilings are the underside of the suspended concrete floor slab for the flat above and they are therefore solid and reasonably well presented. However, the decorative finishes are dated and there has been historic leaks where there is water staining above the kitchen/bathroom. These are now dry, and would not indicate an ongoing leak, but some damp readings were found to the ceiling and walls around the WC/bathroom where there is significant mould growth to the WC area that could be caused leaks from the external hopper or a leak from bathrooms above that requires further investigation.

It was also noted that there are some textured coatings – particularly to the main bedroom and kitchen, which appears to be a textured paint but could also be a textured plaster finish known as Artex. Artex was known to contain an element of asbestos up until the middle 1980's, but the content was relatively low at around 5%. Asbestos is a toxic material not now used in the building industry and the hazard arises from the release of fibres such as when it is worked on and they are inhaled. If they are simply left alone, they are not thought to be a major defect, but you may wish to have them tested to establish if they are an asbestos containing material.

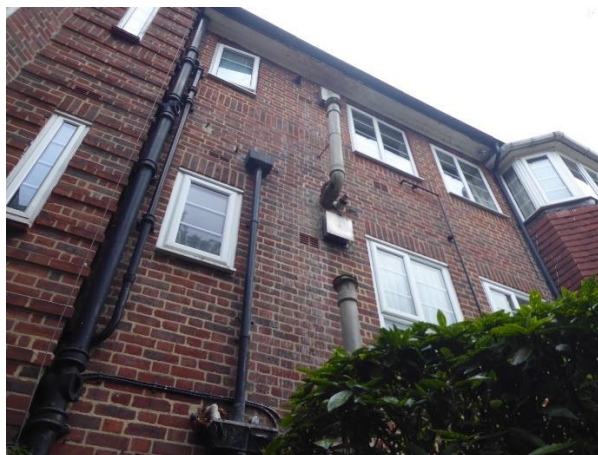
It was noted that there are many original asbestos cement boiler flues remaining in-situ externally. As they are external and do not directly affect the subject property, it is not thought to be a significant hazard, but further enquiries with the managing agent is recommended.

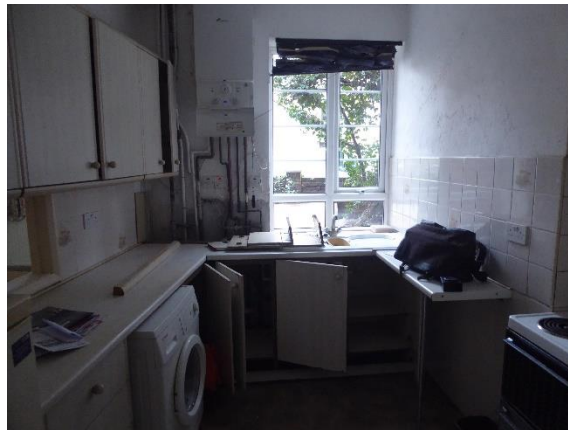
The kitchen has a particularly dated range of base and wall units that are in poor condition and will require replacement. There is a 1.5 bowl composite sink, freestanding electric oven and no integrated appliances. None of the equipment was tested but modernisation will certainly be necessary.

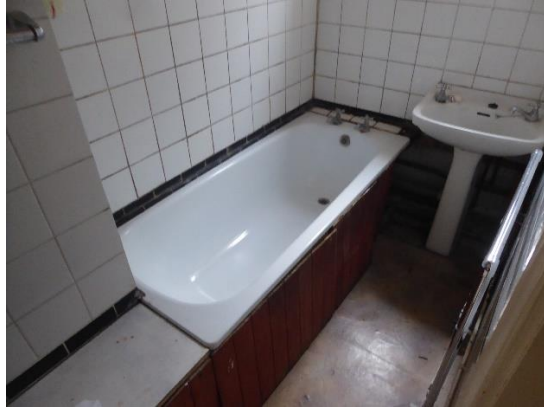
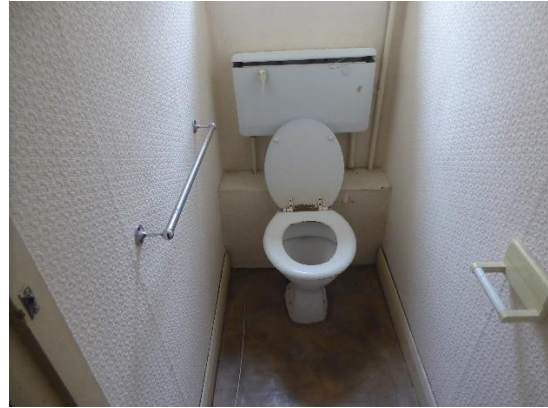
mounted cistern that does not function, as the flush mechanism is defective.

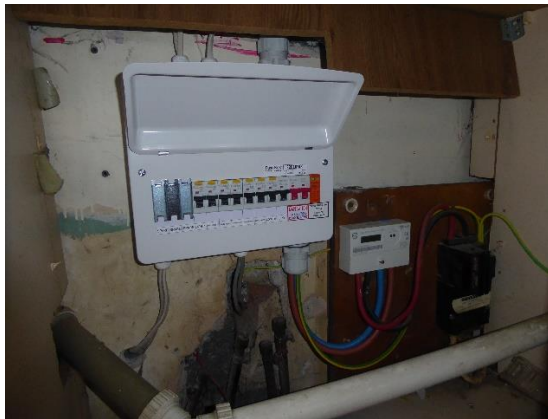
Mains electricity is supplied and the meter is located beneath the base cabinetry to the front left of the kitchen where there is a modern digital meter. The consumer unit is in the same location that is also a relatively modern replacement, which has miniature circuit breaker fusing and it would appear that the flat has been re-wired as there are multiple, relatively modern, sockets where there has been obvious upgrading. You may wish to make further investigation in this respect to establish if there is any certification for this work, but as I am unable to test this type of installation, you should have it tested by a qualified electrician to establish its efficiency before proceeding.
