LEVEL 2

# Your survey and valuation report

74 Square Road, Circle Town, RE3 7AN

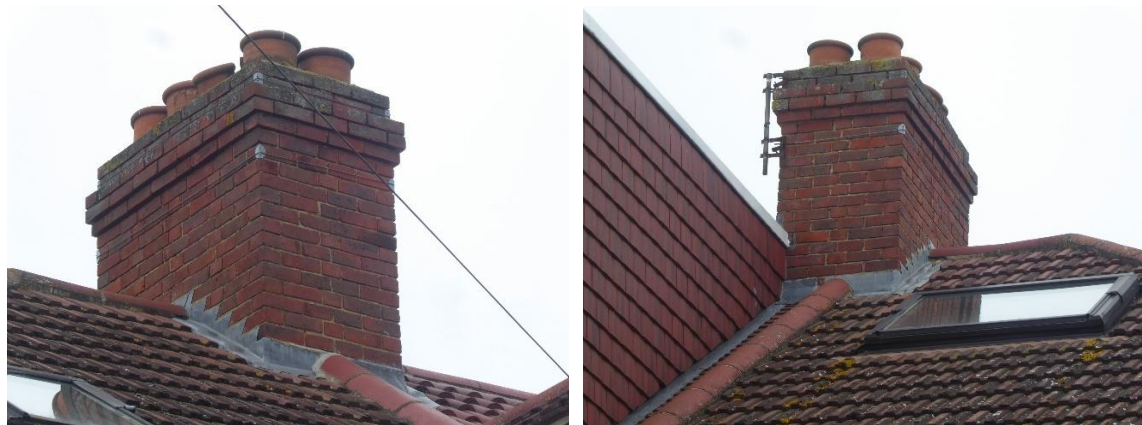
There is a shared chimney stack at ridge height over the party wall. It is constructed of solid brickwork, finished in facing brick, and the brickwork and pointing are in reasonable condition. It retains the original uncapped clay pots that are in fairly poor condition, as the central one towards the front is broken or leaning that should be replaced or removed/capped as there are no functional fireplaces. The seal between the chimney stack and roof covering are sheet and stepped metal flashings that appear to be relatively modern replacements and on discussion with the vendor, this was undertaken at the same time as the loft conversion on the adjoining house within the last five years. However, damp testing was not possible within the roof space as the chimney breasts have been boxed in as part of the DIY type conversion. No work is thought to be urgent but the defective pot should ideally be addressed sooner rather than later as if it were to fall, it could be a hazard.

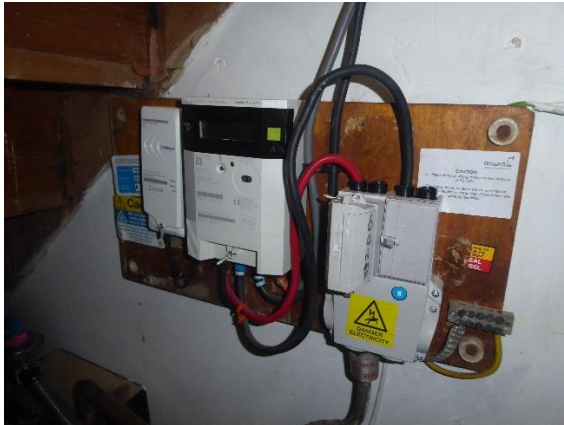
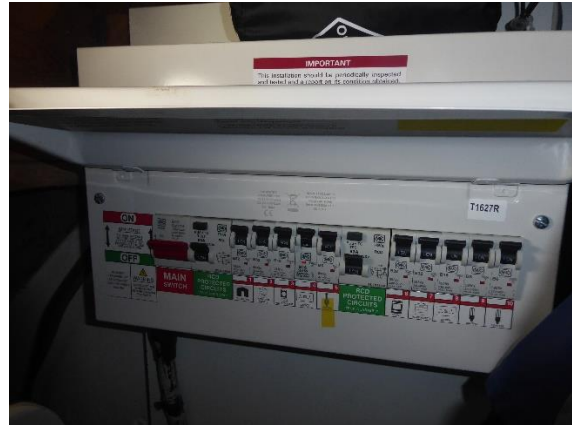
Mains electricity is supplied and the meter is located in the understair cupboard, which is a modern digital replacement. The consumer unit is in the same location, which has been upgraded relatively recently to a modern type with miniature circuit breaker fusing and RCD protection. This was likely undertaken around 2018 and should be tested this year as recommended by the sticker on the unit. The sockets and switches throughout are relatively modern, which could indicate there has been some upgrading, but it could not be verified if the property has been fully rewired. As I am unable to test this type of installation, I recommend that you have it tested by a qualified electrician to establish its efficiency before proceeding.

There is also a power supply to the outbuilding, which should be tested at the same time as I could not locate a separate consumer unit that may or may not be present.

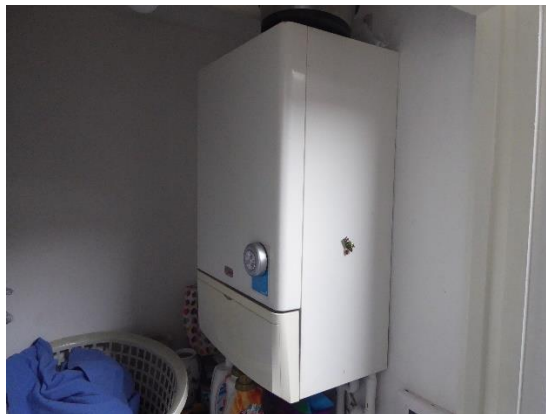
The house is centrally heated by pressed steel radiators most of which are relatively modern replacements and the vendor did state that they have upgraded these as part of their six year occupancy. These have convector fins, and most have individual thermostatic control valves, but the hot water is provided by a relatively dated gas fired, wall mounted Alpha combi boiler, which is located within the service cupboard to the utility space with a flue exiting out the rear wall of the extension.

The system was in use during inspection and appears to function effectively, but as I am unable to test this type of installation, I recommend that you have it tested by a qualified heating engineer to establish its efficiency before proceeding.
